**Flood Control Project Maintenance
Levee Inspections**

Fall 2016 Levee Maintenance Deficiency Summary Report

Sacramento River Basin

Sacramento Maintenance Yard Sacramento Bypass

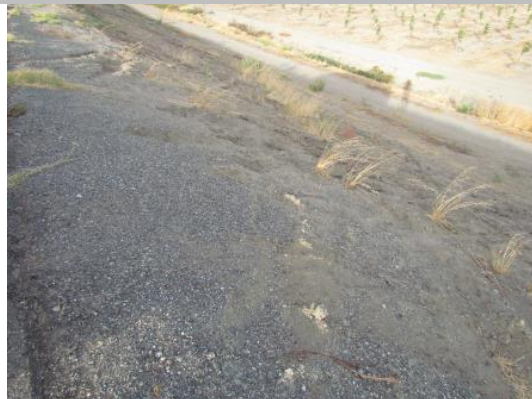
Photo 1 of 1 : FA_2016_ST0008_284_6_20161013_00008.jpg

LM Start	0.08	Rating **	M	Issue No.	6
LM End	0.08	Issue Type +	Ma	Location *	LS
Category	Earthen Levee			GPS Latitude/Longitude	
				Start	End
Item	Slope Stability			38.606622 °	38.606622 °
				-121.561266 °	-121.561266 °
DWR ID	DWR_ST0008_01_f_2016_6				
Comment Code					
S3 : Repair the levee slope damaged by vehicle traffic and prevent access where possible.					
Inspector Comment

Slope stability issue caused by vehicles. Fall 2016.

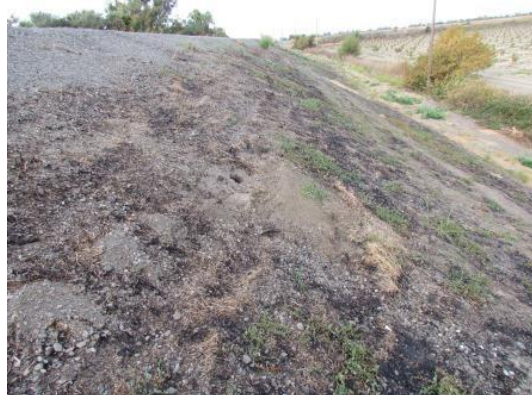
Photo 1 of 2 : FA_2016_ST0008_284_10_20161013_00009.jpg

LM Start	0.94	Rating **	M	Issue No.	10
LM End	0.94	Issue Type +	Ma	Location *	LS
Category	Earthen Levee			GPS Latitude/Longitude	
				Start	End
Item	Animal Control			38.602763 °	38.602763 °
				-121.576288 °	-121.576288 °
DWR ID	DWR_ST0008_01_f_2015_10				
Comment Code					
A3 : No rodents visible, but rodent burrows visible; need to backfill and compact or grout burrows.					
Inspector Comment

An updated view of the rodent holes on LS slope. Fall 2016.

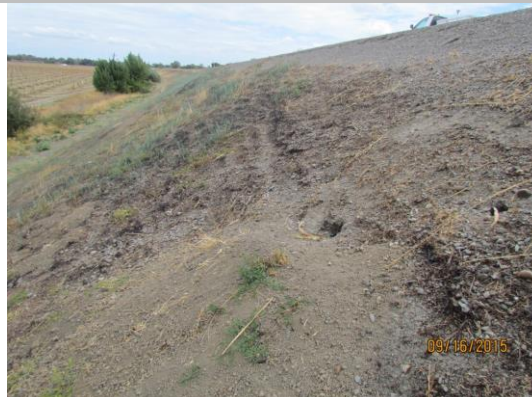
Photo 2 of 2 : FA_2016_ST0008_284_10_20160913_00001.jpg

View of the rodent holes on the landward side of the levee looking upstream. Fall 2015.

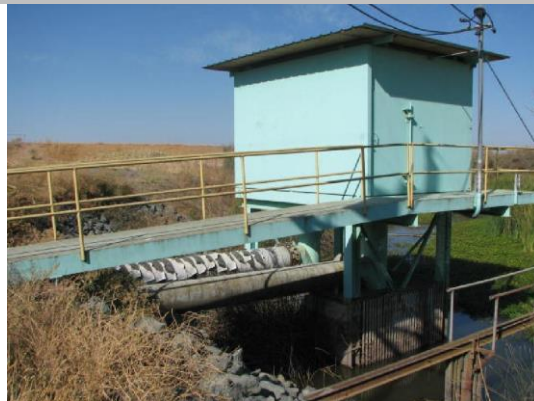
Photo 1 of 2 : UCIP_FA_2016_44783_20611.jpg

LM Start	1.10	Rating **	M	Issue No.	11
LM End	1.10	Issue Type +	En	Location *	LS
Category	Supplemental			GPS Latitude/Longitude	
				Start	End
Item	DWR UCIP Field Study			38.602180 °	38.602180 °
				-121.579130 °	-121.579130 °
DWR ID					
Comment Code					
Inspector Comment					
FS_ID:44783 DS_ID:19066 EP_NO: 13616 Repair Type: Non-Urgent Crossing Status: Found UCIP Comments: After more investigation depressions are from water run off. erosion repair needed FIELD_STRUCT_DESC: 1 of 2. A agriculture drainage pumping system with 24-inch and 20-inch steel discharge pipelines through the north levee of the Sacramento Bypass. The pipe is 6.33 ft below the crown and a siphon breaker on the WS. Vertical GI pipe trash rack on inlet structure. Application no. 13616, 1995 (revised). FS Date: 4/28/2015 2:43:01 PM

Landside view: pumping plant overview

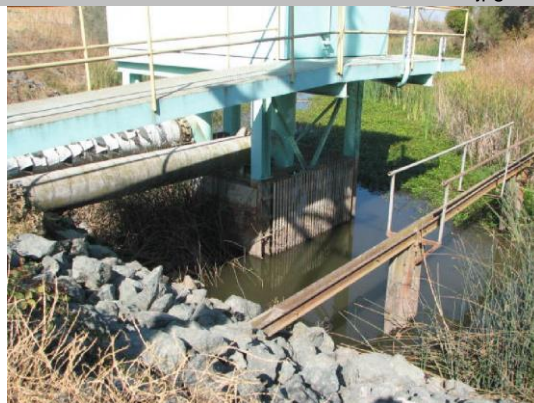
Photo 2 of 2 : UCIP_FA_2016_44783_20609.jpg

Landside view: vertical GI pipes in inlet structure.

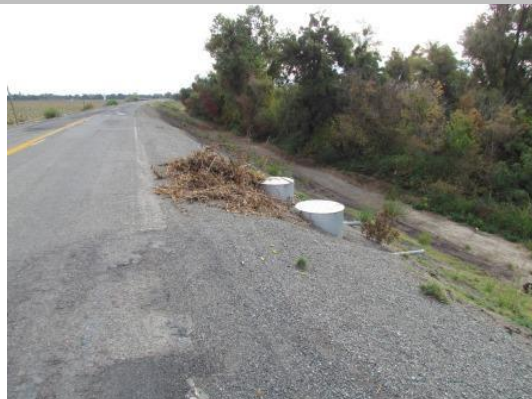
Photo 1 of 1 : FA_2016_ST0008_284_7_20161013_00010.jpg

LM Start	1.10	Rating **	M	Issue No.	7
LM End	1.10	Issue Type +	Ma	Location *	WS
Category	Earthen Levee			GPS Latitude/Longitude	
				Start	End
Item	Encroachments			38.602113 °	38.602113 °
				-121.579128 °	-121.579128 °
DWR ID	DWR_ST0008_01_f_2016_7				
Comment Code					
DE : Debris					
Inspector Comment

View of debris on WS slope of the levee. Fall 2016.

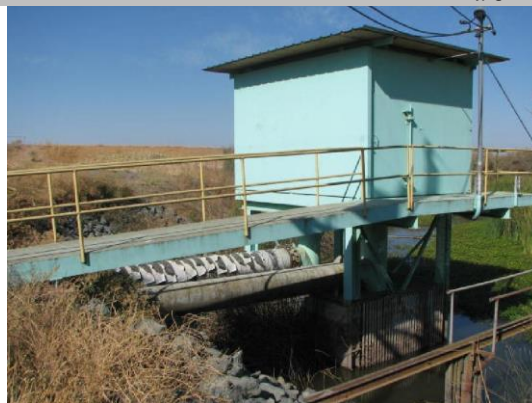
Photo 1 of 2 : UCIP_FA_2016_44784_20619.jpg

LM Start	1.10	Rating **	M	Issue No.	12
LM End	1.10	Issue Type +	En	Location *	WS
Category	Supplemental			GPS Latitude/Longitude	
				Start	End
Item	DWR UCIP Field Study			38.602128 °	38.602128 °
				-121.579150 °	-121.579150 °
DWR ID					
Comment Code					
Inspector Comment					
FS_ID:44784 DS_ID:19079 EP_NO: 13616 Repair Type: Non-Urgent Crossing Status: Found UCIP Comments: Horizontal Air vent on waterside slope. Green vegetation and depressions also found on waterside slope. FIELD_STRUCT_DESC: 2 of 2. A agricultural drainage pumping system with 24-inch and 20-inch steel discharge pipelines through the north levee of the Sacramento Bypass. The pipe is 6.33 ft below the crown and a siphon breaker on the WS. Vertical GI pipe trash rack on inlet structure. Application no. 13616, 1995 (revised). FS Date: 4/28/2015 2:43:26 PM

Landside view: overview of pumping plant

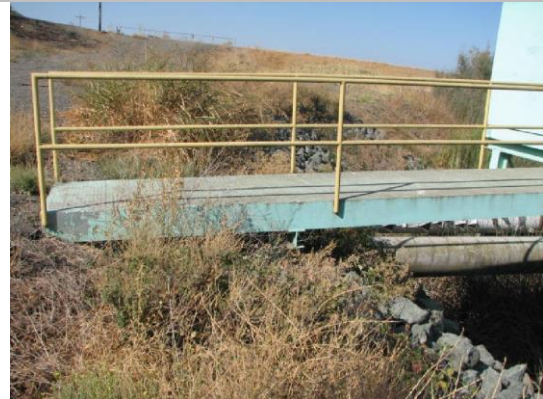
Photo 2 of 2 : UCIP_FA_2016_44784_20618.jpg

Landside view: walkway to the pumping plant

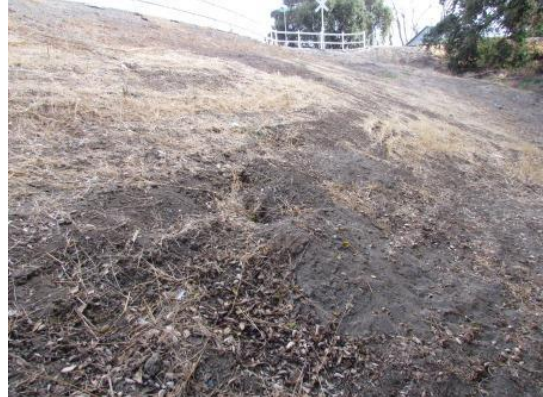
Photo 1 of 1 : FA_2016_ST0008_285_2_20161013_00002.jpg

LM Start	0.03	Rating **	M	Issue No.	2
LM End	0.03	Issue Type +	Ma	Location *	LS
Category	Earthen Levee			GPS Latitude/Longitude	
				Start	End
Item	Animal Control			38.602613 °	38.602613 °
				-121.556021 °	-121.556021 °
DWR ID	DWR_ST0008_02_s _ 2016_2				
Comment Code					
A3 : No rodents visible, but rodent burrows visible; need to backfill and compact or grout burrows.					
Inspector Comment

View of rodent holes on LS slope of the levee near entry gate. Fall 2016..

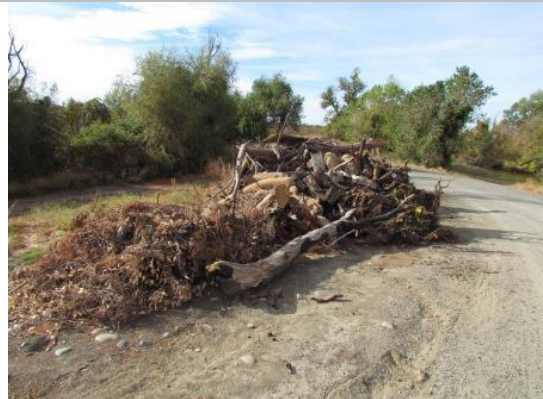
Photo 1 of 2 : FA_2016_ST0008_285_5_20161013_00003.jpg

LM Start	1.78	Rating **	M	Issue No.	5
LM End	1.78	Issue Type +	Ma	Location *	LS
Category	Earthen Levee			GPS Latitude/Longitude	
				Start	End
Item	Encroachments			38.594702 °	38.594702 °
				-121.586604 °	-121.586604 °
DWR ID	DWR_ST0008_02_s_2016_5				
Comment Code					
DE : Debris					
Inspector Comment					
This is a seasonal pile but gets burned by the LMA each year.

More debris was added to the pile since the time of last inspection. Fall 2016.

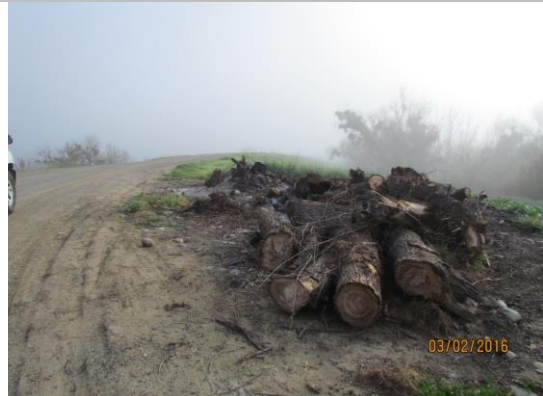
Photo 2 of 2 : FA_2016_ST0008_285_5_20160913_00001.jpg

View of the firewood on the landward side of the levee looking upstream. Spring 2016.
